TS-PIC-9903410S/20003410S  
January 2000

# AERIAL PHOTOGRAPHIC ANALYSIS INDUSTRIAL ENTERPRISES SITE Rosedale, Maryland

EPA Region 3

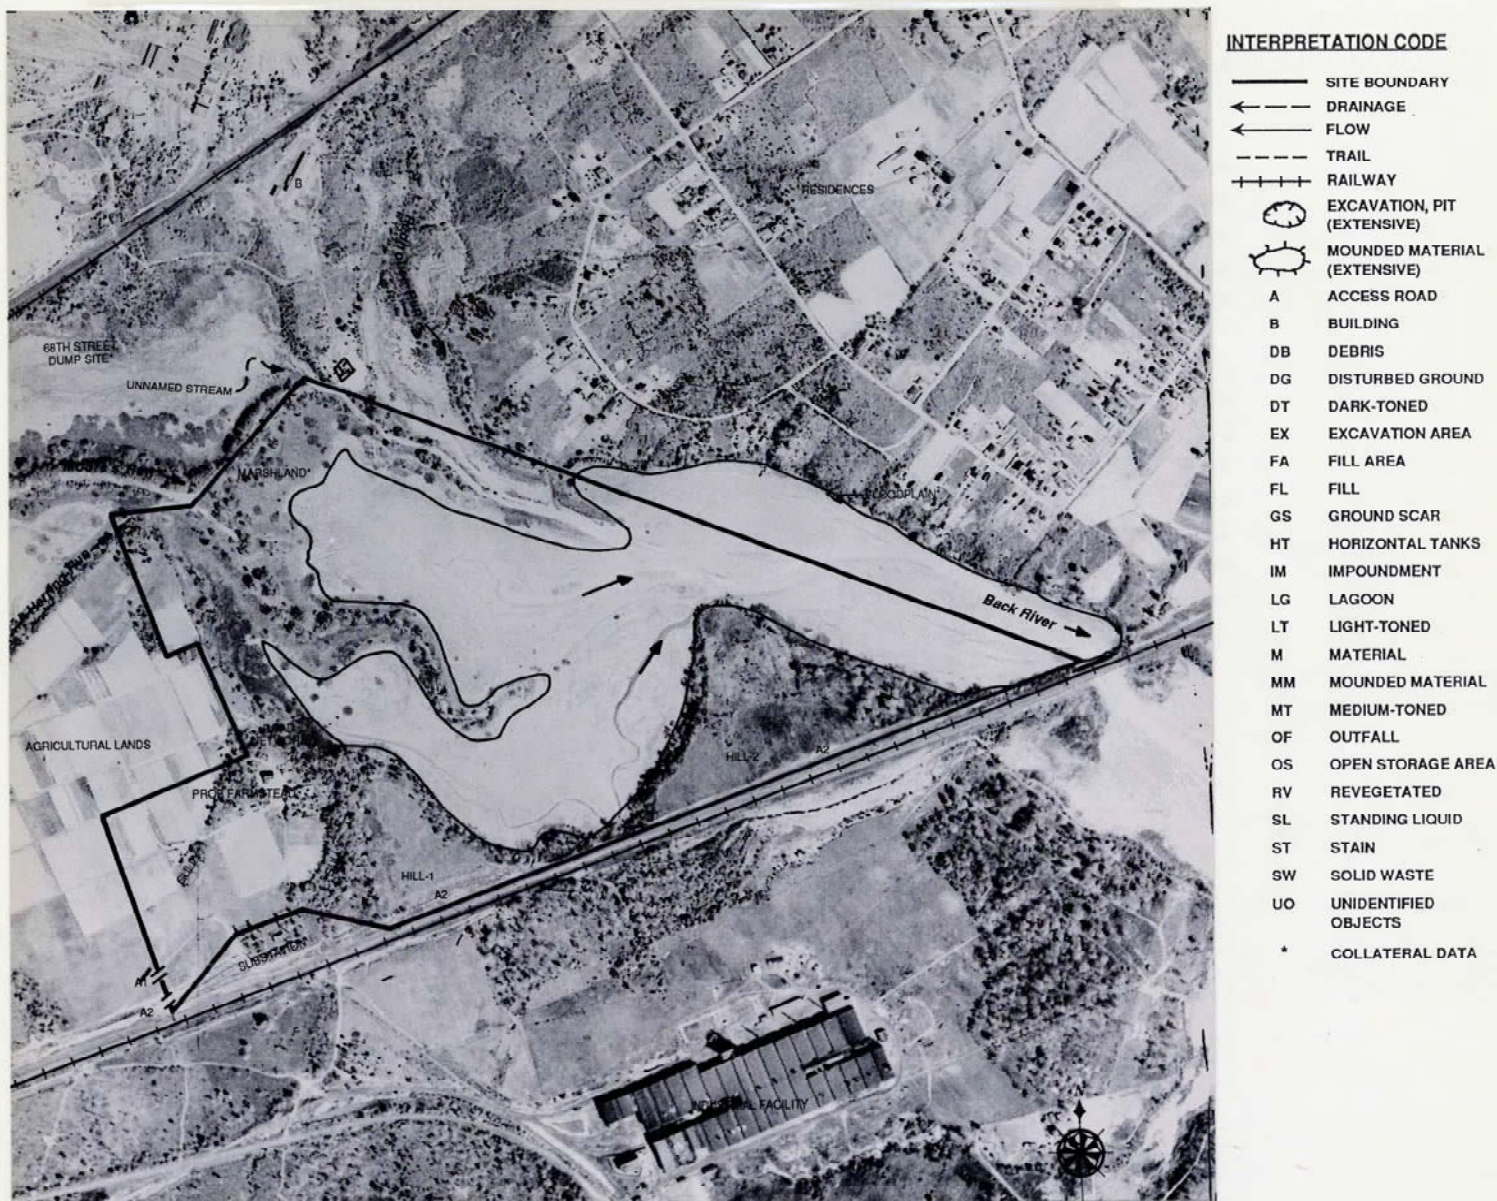
Figure 3. Industrial Enterprises site, April 23, 1938. Approximate scale 1:6,630.

APRIL 23, 1938 (FIGURE 3)

Initial coverage of the Industrial Enterprises site shows a marshland prior to development. The central and eastern portions of the site are predominately occupied by a floodplain of the Back River. The eastern side of this floodplain extends beyond the eastern site boundary. The western side of this floodplain merges with a relatively flat and muddy shoreline of the marshland. The shoreline is at the toe of a western slope with a relatively-flat top. Agricultural lands extend from the head of this slope to beyond the western site boundary. In the southwestern portion of the site, an access road (A1) leads from the western site boundary to a probable farmstead situated between two gullies. A network of roads on the northern side of this farmstead connects between the farmstead and the western site boundary. East of access road A1, two flat-topped elevated areas are identified as Hill-1 and Hill-2 for the purposes of this analysis. Segments of another access road (A2) are visible south of access road A1 and along the southern sides of both Hill-1 and Hill-2.

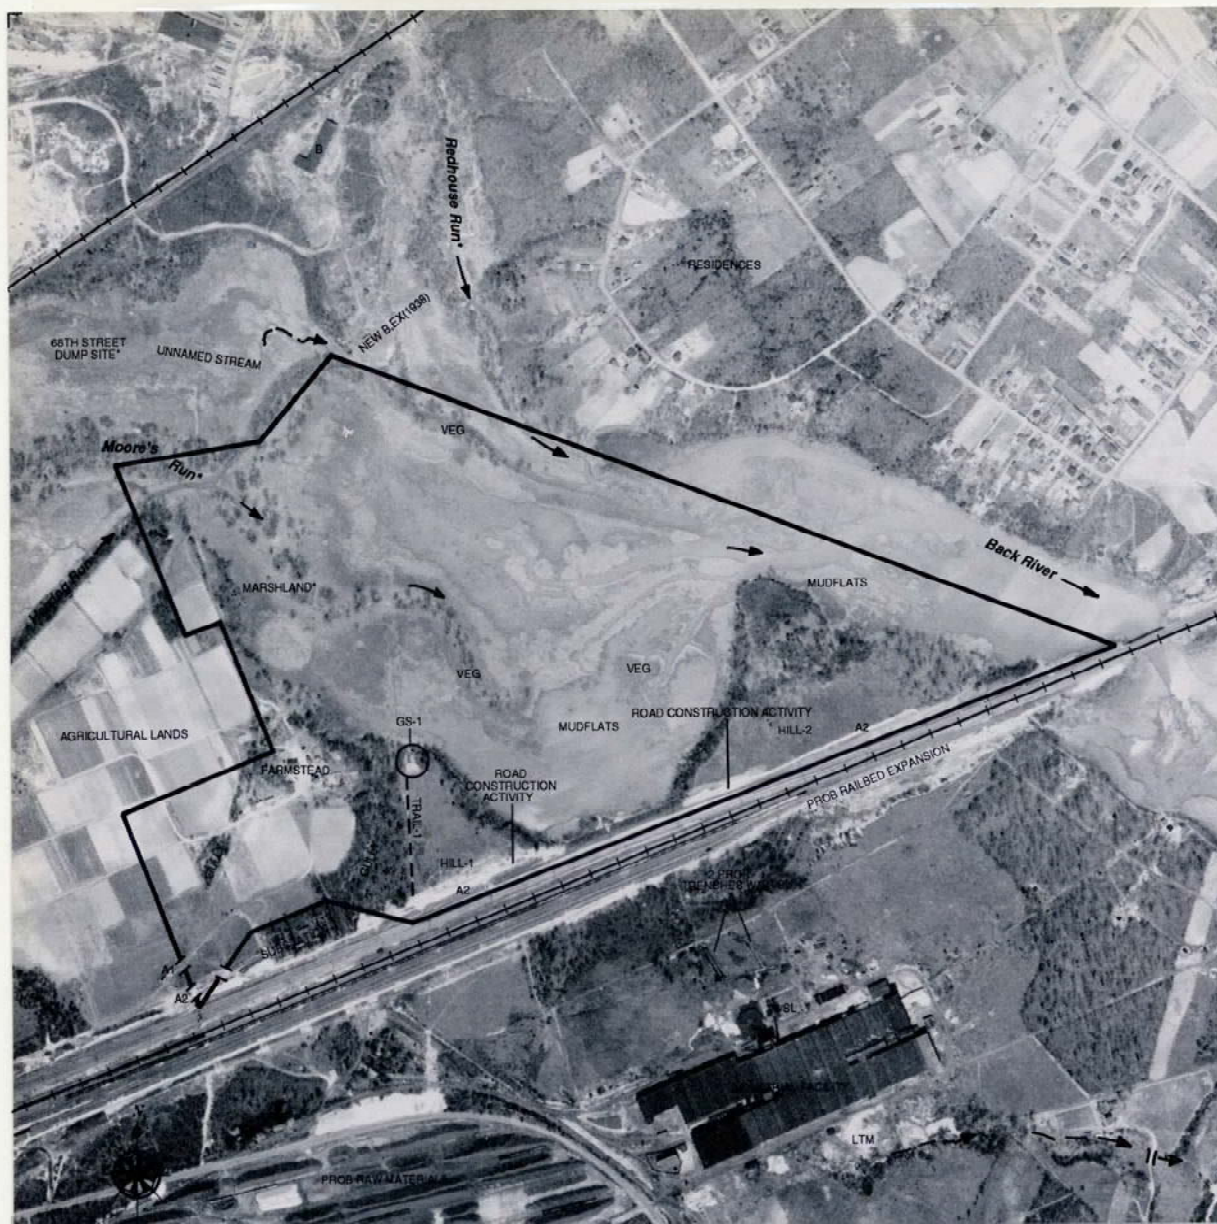
Figure 4. Industrial Enterprises site, April 25, 1943. Approximate scale 1:6,530.

APRIL 25, 1943 (FIGURE 4)

The farmstead observed in 1938 appears relatively unchanged. Probable road construction activity along access road A2 is visible at the southern sides of both Hill-1 and Hill-2. At Hill-1, a trail (Trail-1) extends northward to a ground scar (GS-1) located on the edge of this hill. Mud flats and vegetation (VEG) are visible in the central and eastern portions of the site.

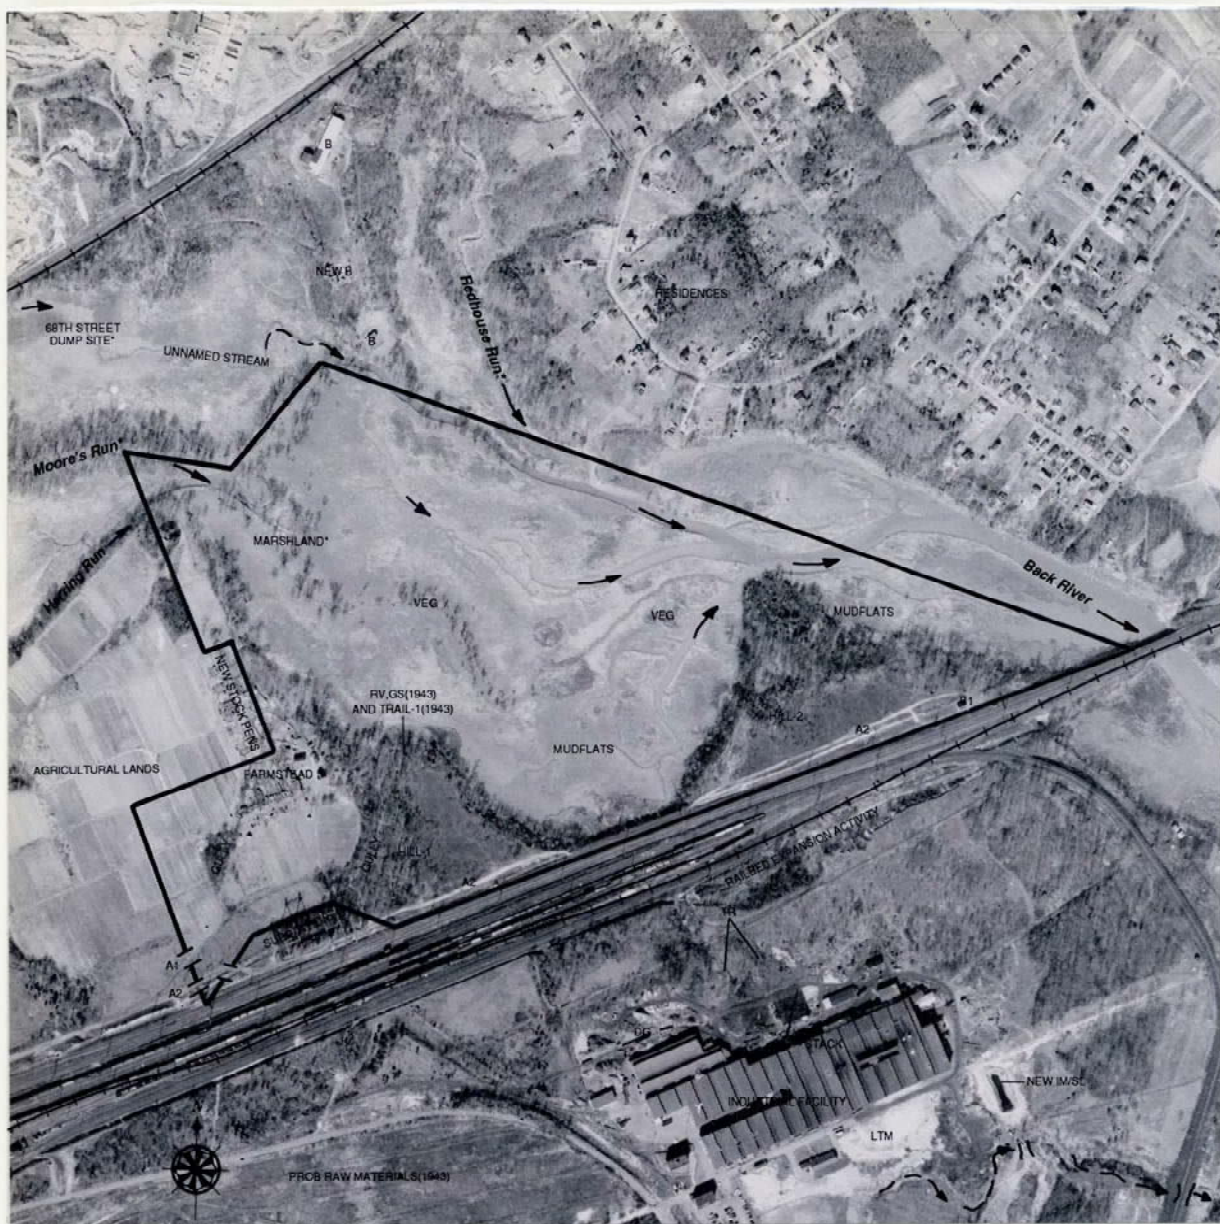
Figure 5. Industrial Enterprises site, February 14, 1953. Approximate scale 1:6,490.

FEBRUARY 14, 1953 (FIGURE 5)

Due to revegetation (RV) the trail and ground scar observed in 1943 are no longer visible at Hill-1. It is probable that operations at the farmstead have increased, due to the presence of new stock pens which extend northward from the farmstead buildings and across the western site boundary.

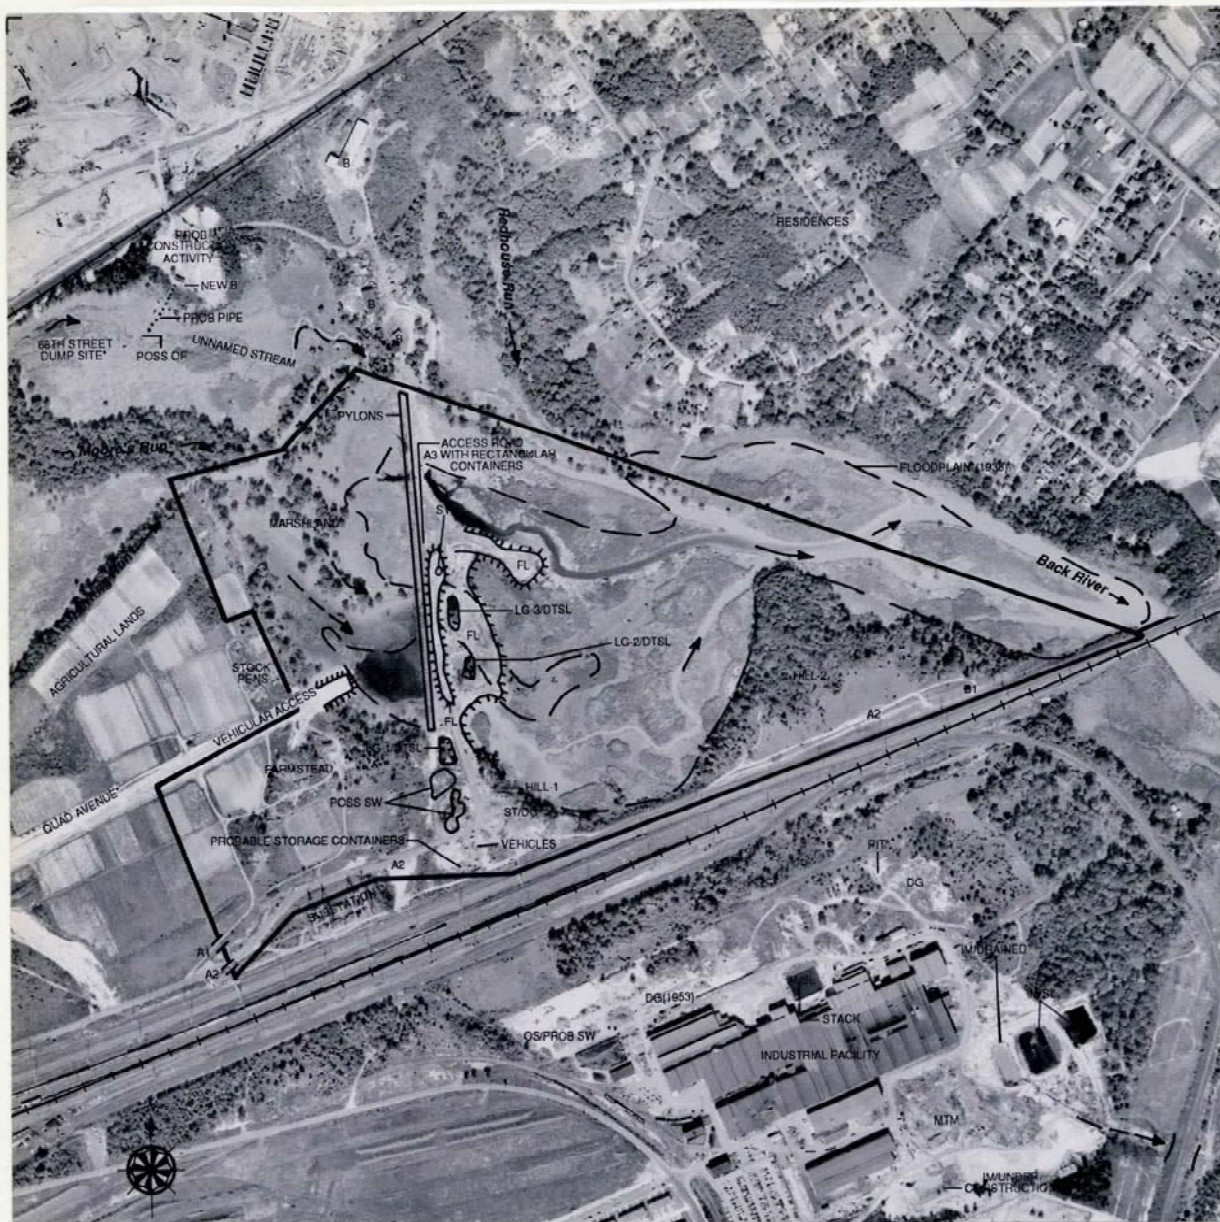
Figure 6. Industrial Enterprises site, September 25, 1957. Approximate scale 1:6,700.

SEPTEMBER 25, 1957 (FIGURE 6)

The approximate location of the floodplain initially identified and delineated on the 1938 photograph (Figure 3) is represented by dashed lines on this photograph.

Along the western site boundary, construction of Quad Avenue\* has bisected the farmstead property and it is possible that the level of activity of the agricultural and livestock operations at the farmstead has been reduced. Since 1953 deposition and manipulation of fill materials has occurred on Hill-1 and on the portion of the floodplain that was located between the northern side of Hill-1 and the northeastern site boundary. These fill materials include light-toned probable fill (FL) and possible solid waste material (SW). North of Hill-1, a row of evenly-spaced pylons demarcates the pre-existing marshland to the west and the newly filled portion of the floodplain to the east. Hill-1 now appears to be a staging area for probable landfilling operations onsite and includes the following features: lagoon (LG-1) containing dark-toned standing liquid, irregularly shaped mounds of possible solid waste, a ground surface primarily comprised of stained (ST) and disturbed ground, an accumulation of probable storage containers (lack of photographic resolution precludes positive identification of drums), numerous dump truck vehicles, and expansion (not annotated) of access road A2. North of Hill-1 and west of the row of pylons, the flow of water from the marshland has ponded (annotated as Probable Pond), probably as a result of the blockage formed by the deposition of fill material. East of the row of pylons, the following features are observed: a new access road (A3), numerous rectangular containers, an extensive mound of probable fill material with a stain on its northern side, and two lagoons (LG-2 and LG-3) containing dark-toned standing liquid (DTSL).

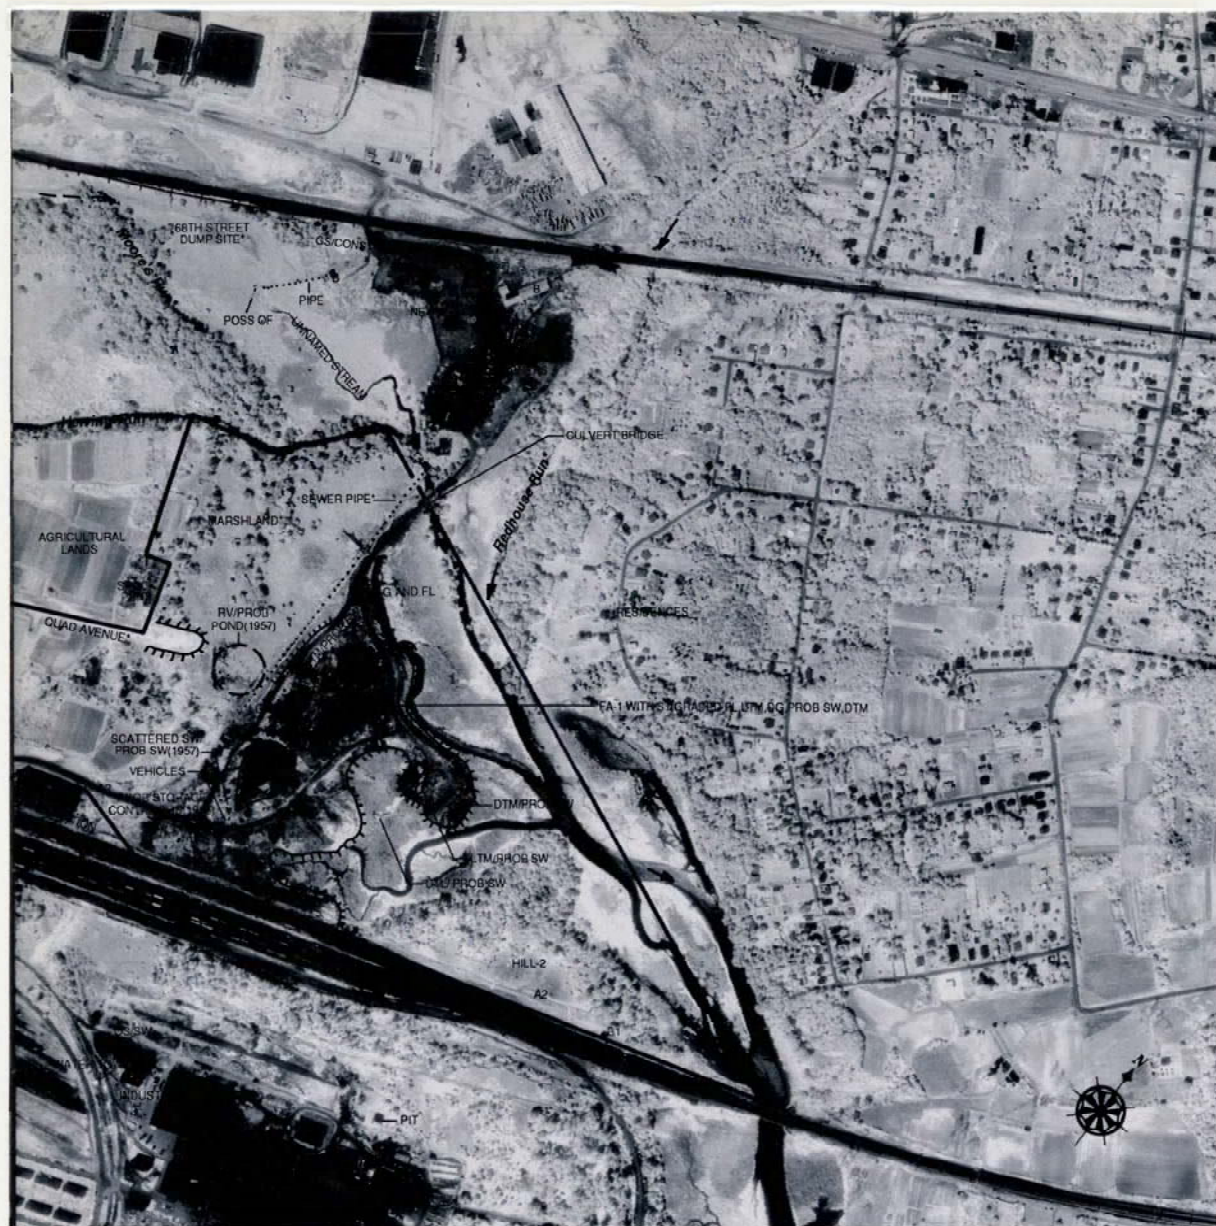
Figure 7. Industrial Enterprises site, August 2, 1960. Approximate scale 1:7,440.

AUGUST 2, 1960 (FIGURE 7)

The southwestern portion of the site is located near the edge of both film transparencies of the stereo pair, and was partially viewed monoscopically. This portion of the site appears relatively unchanged since 1957. Due to the location of the site near the edge of the film transparency selected for enlargement, the southwestern corner of this portion of the site was omitted.

The farmstead property appears relatively unchanged since 1957. The row of pylons observed in 1957 now supports a sewer pipe\*. Both ends of this sewer pipe remain buried, so an outfall point is not discernible. The previously discrete Hill-1 has merged with a new fill area (FA-1), which is filled with medium-toned material. Since 1957, the extent and contents of lagoon LG-1 have increased to the south, where the material comprising the irregularly shaped mound of probable solid waste observed in 1957 now appears to be scattered. The ground surface remains primarily comprised of stains, graded fill, disturbed ground, and accumulations of probable solid waste, which exhibit a mottled surface appearance. Lack of photographic resolution precludes the identification of the probable storage containers observed in 1957. Near the southern site boundary, numerous vehicles remain discernible on and around access road A2. To the north and west of the sewer pipe, revegetation obscures the probable pond observed in 1957. East of the sewer pipe, the two lagoons (LG-2 and LG-3) continue to contain dark-toned standing liquid and a fourth lagoon (LG-4) containing dark-toned standing liquid has been installed. Although these lagoons are not readily discernible on the print, resolution of their locations was possible through stereoscopic analysis of the photo transparencies. Access road A3 has been extended past the northeastern site boundary, where a culvert bridge is now present. This bridge provides access to the eastern portion of the adjacent 68th Street Dump site, where a new incinerator stack has been installed and probable waste disposal containers are noted. A ground scar is visible at the previous location of probable construction activity.

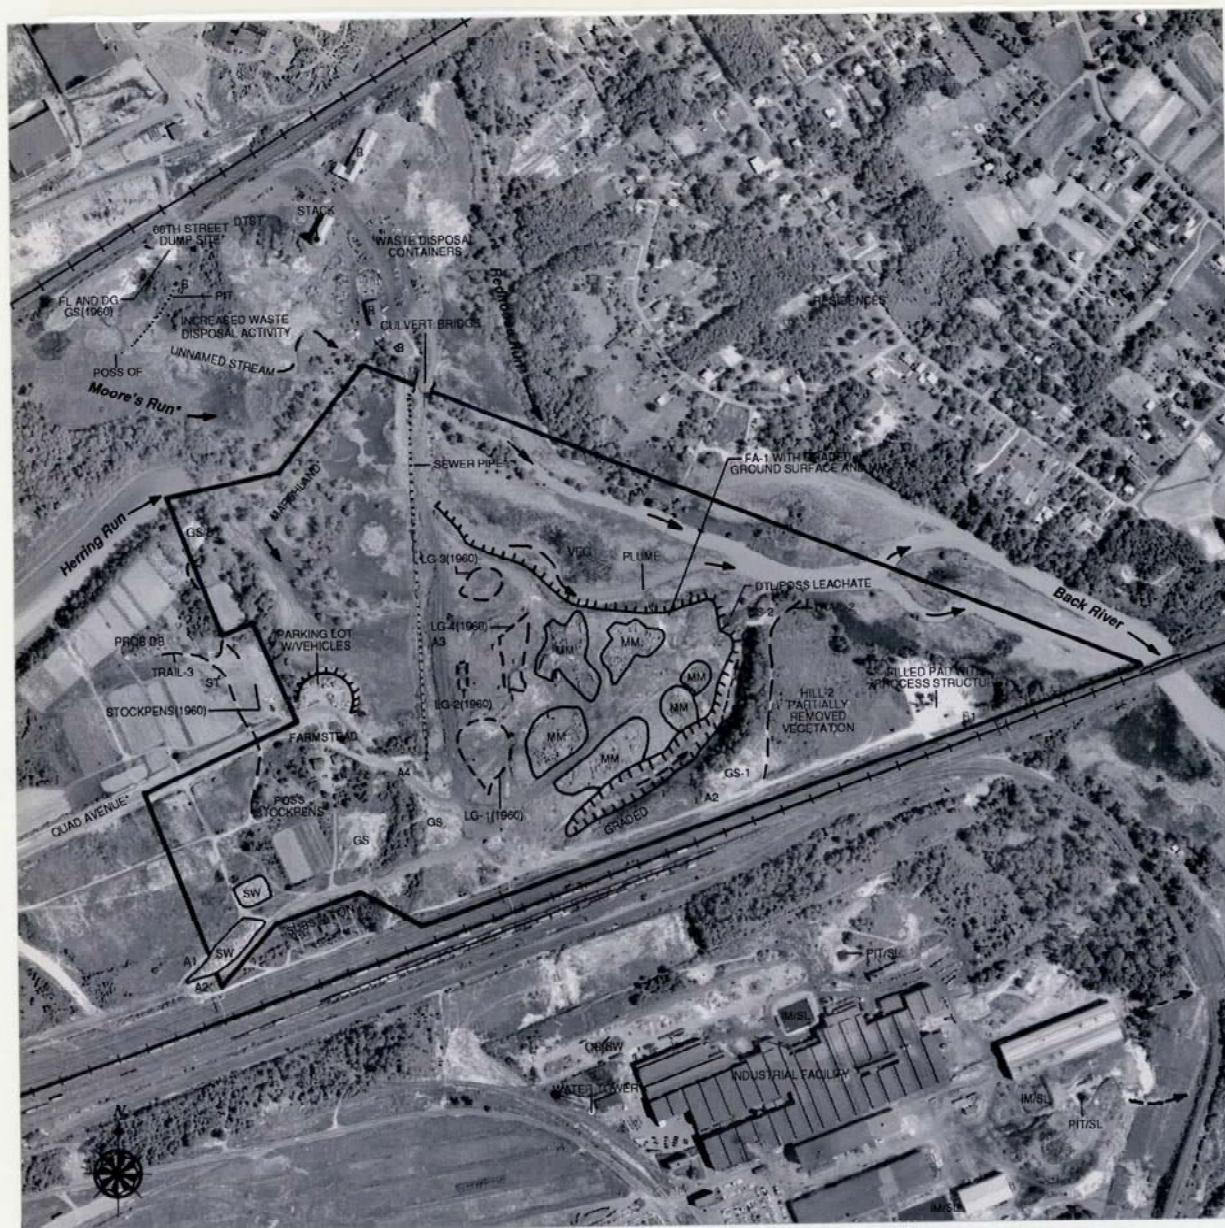
Figure 8. Industrial Enterprises site, May 18, 1964. Approximate scale 1:6,630.

MAY 18, 1964 (FIGURE 8)

Since 1960 a vehicle parking lot has been installed at the eastern end of Quad Avenue, and is adjacent to where a new access road (A4) begins. Access road A4 extends along the northern and eastern sides of the remaining farmstead buildings. South of the farmstead, there are land parcels with solid waste and ground scars, where the network of roads has expanded (not annotated). Within the western site boundary, possible stock pens are located southwest of the farmstead.

East of the sewer pipe, at fill area FA-1, the location of the four lagoons (LG1 through LG4) observed in 1960 is now covered by with medium-toned material. Fill area FA-1 now extends eastward from access road A3 to the Back River. Along the northeastern base of this fill area, in the adjacent floodplain channel, a plume is discernible. Dump truck-sized mounds of material (MM) are visible on the graded surface of fill area FA-1. Near the southern site boundary and west of Hill-2, a graded ground surface is noted. At Hill-2, the following features are noted since 1960: most of the canopied vegetation has been removed from the central portion of Hill-2, a trail (Trail-2) extends between two ground scars (GS-1 and GS-2), north of building B1, a filled pad bearing a process structure has been installed. Off the northern side of Hill-2, a pool of dark-toned liquid (DTL) is identified as a possible pooling of leachate from the adjacent filled area. Near the western site boundary, the stock pens have been removed from north of the farmstead. The removal of these stock pens is possibly associated with the following nearby features: a ground stain, an accumulation of probable debris (DB), and a trail (Trail-3) which leads both northward to an area with a ground scar and a stain, and southward to possible stock pens.

At the adjacent 68th Street Dump site to the north, dark-toned stains are visible north of the incinerator stack. At and along the western side of a former ground scar, an area with light-toned probable fill material and disturbed ground is identified. An increase in the quantity of waste disposal containers indicates an increased level of waste disposal operations. At the industrial facility to the south, the following new features are noted: an increase in the number of structures (not annotated), a previously observed pit that now contains standing liquid and a new pit containing standing liquid.

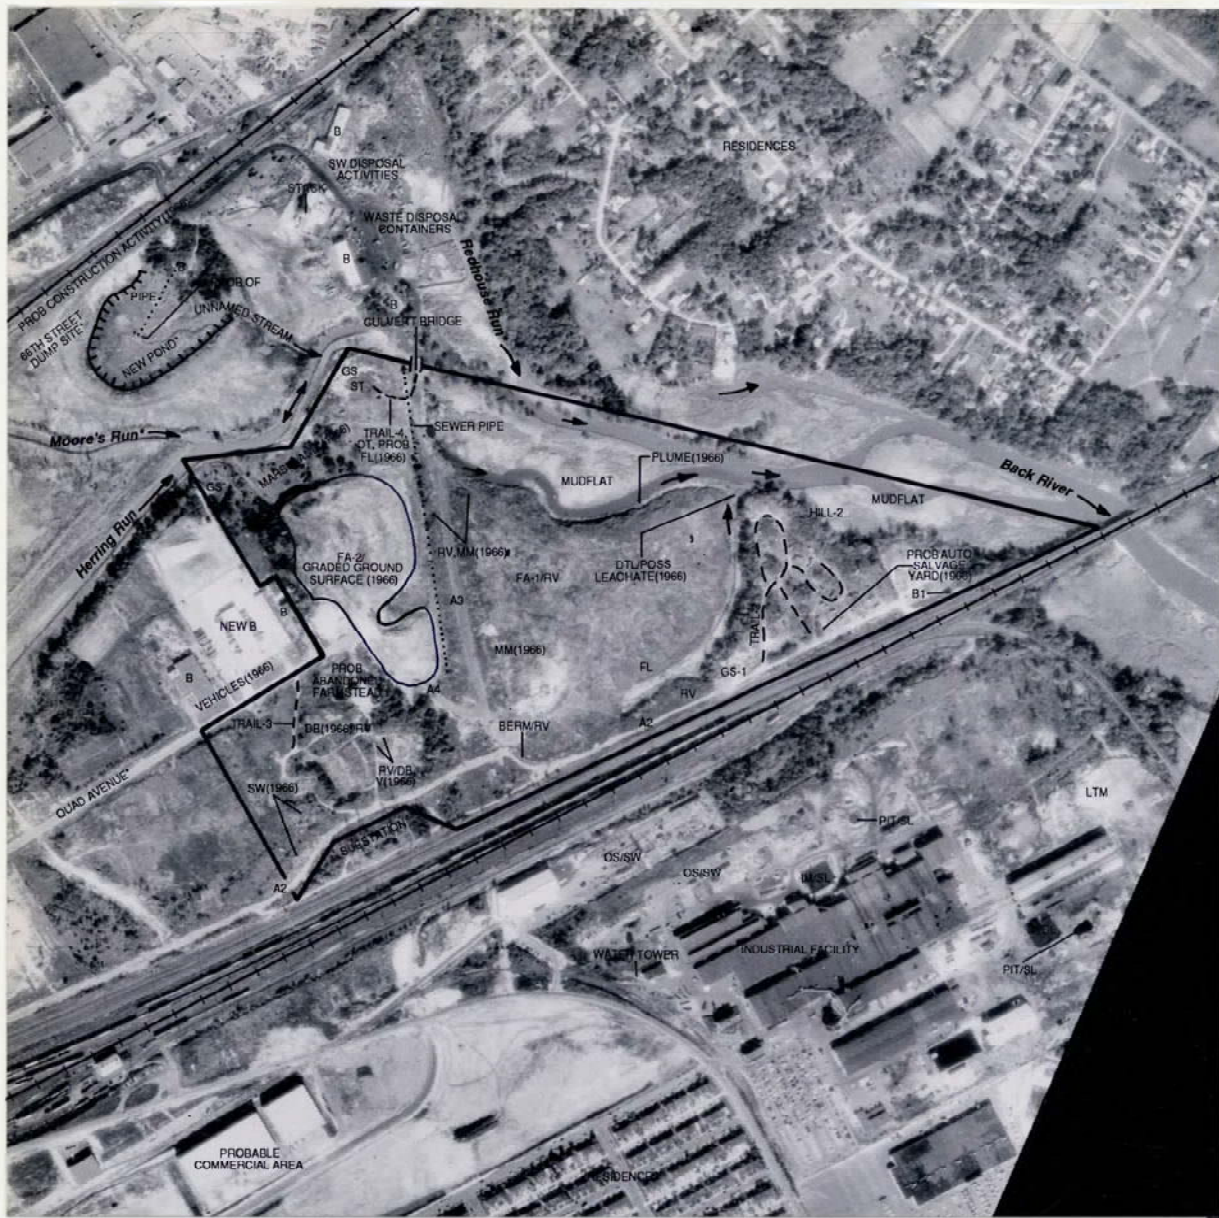
Figure 10. Industrial Enterprises site, October 1968. Approximate scale 1:7,200.

OCTOBER 1968 (FIGURE 10)

The farmstead, now identified as probably abandoned, and a portion of Trail-3 remain visible since 1966. South of the probable abandoned farmstead, the previous locations of vehicles, debris, and solid waste are obscured by revegetation.

Within the northern site boundary, the dark-toned probable fill material observed in 1966 is now identified as a trail (Trail-4), which leads westward to an area with ground scarring and staining. To the south, on the marshland observed in 1966, a graded fill area (FA-2) has been established. At the eastern end of Quad Avenue, the vehicles observed in 1966 have been removed. The surface of fill area FA-1 and the berm appear to be revegetating. The location of the plume previously discerned along the northeastern base of this fill area is not readily discernible. The addition of fill material to the southern side of FA-1 since 1966 is noted. Further south, the graded ground surface visible since 1964 has revegetated. At Hill-2, most of the contents of the probable auto salvage yard evident in 1966 have been removed. Trail-2 has expanded into a road network and ground scar GS-1 remains visible.

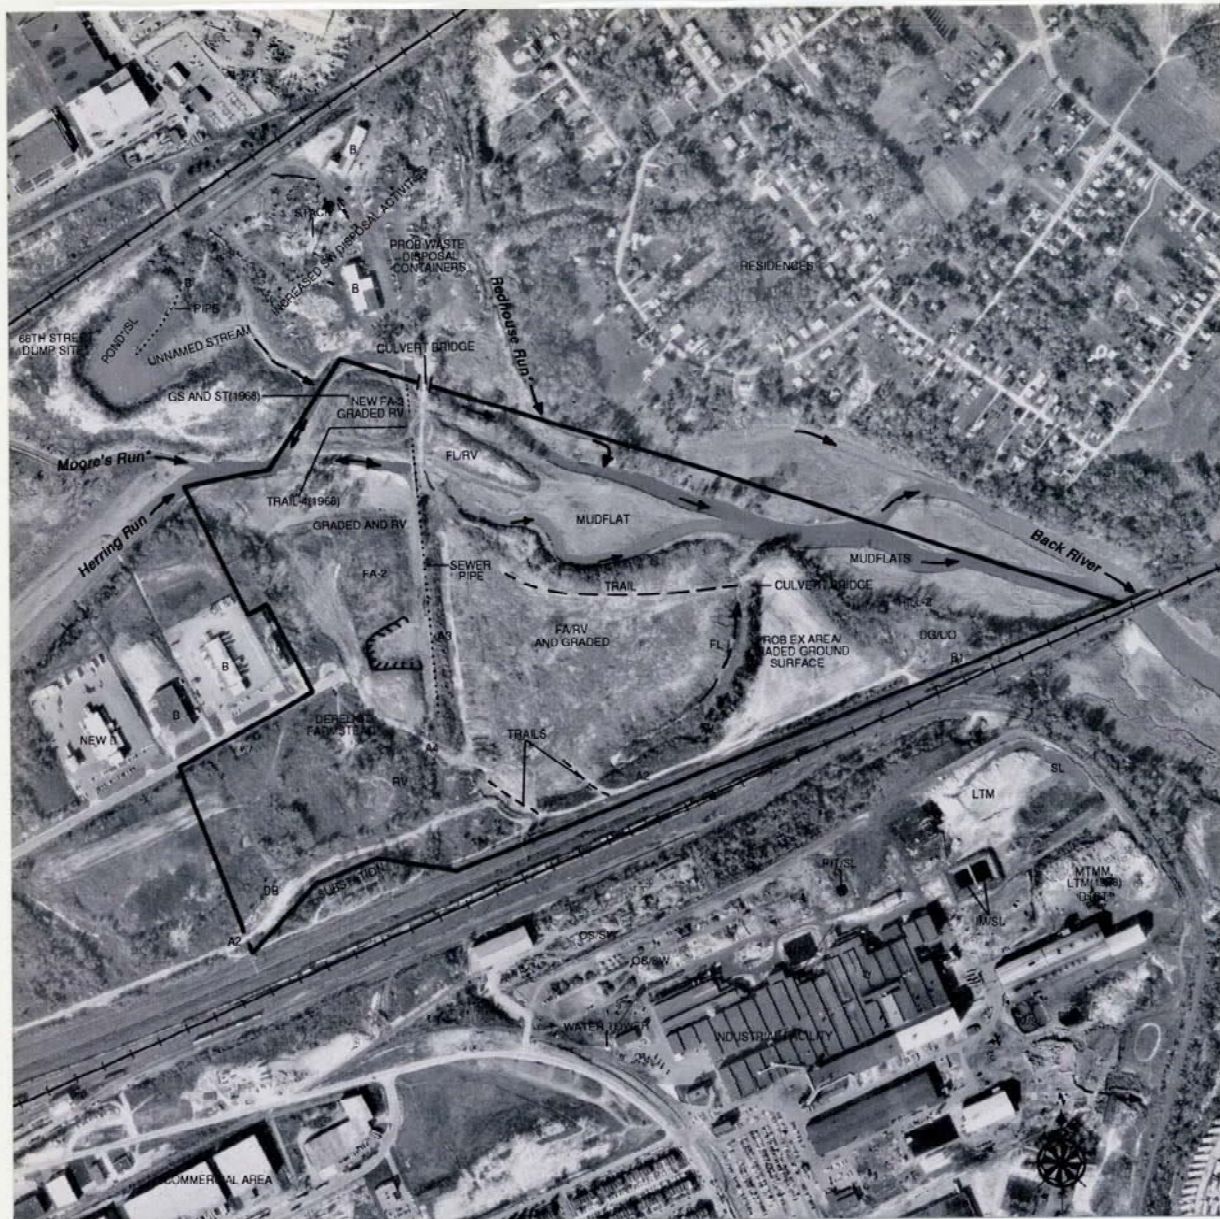
Figure 11. Industrial Enterprises site, November 5, 1971. Approximate scale 1:7,000.

NOVEMBER 5, 1971 (FIGURE 11)

Within the northern site boundary, a new fill area (FA-3) obscures the former locations of Trail-4, the area with ground scarring and staining observed in 1968, and a portion of the sewer pipe. To the south, a new excavation area is present along the southern side of FA-2. Since 1968 the addition of fill material along the southern side of FA-1 and a new culvert bridge at the easternmost side of FA-1 are noted. Trails are noted on the surface of fill area FA-1. The surfaces of the three fill areas (FA-1, FA-2, and FA-3) exhibit grading and revegetation. At Hill-2, the top is now identified as a probable extraction area with a graded ground surface. It is possible that the topsoil from Hill-2 has been used on the three fill areas in the site. North of building B1, disturbed ground and unidentified objects are present.

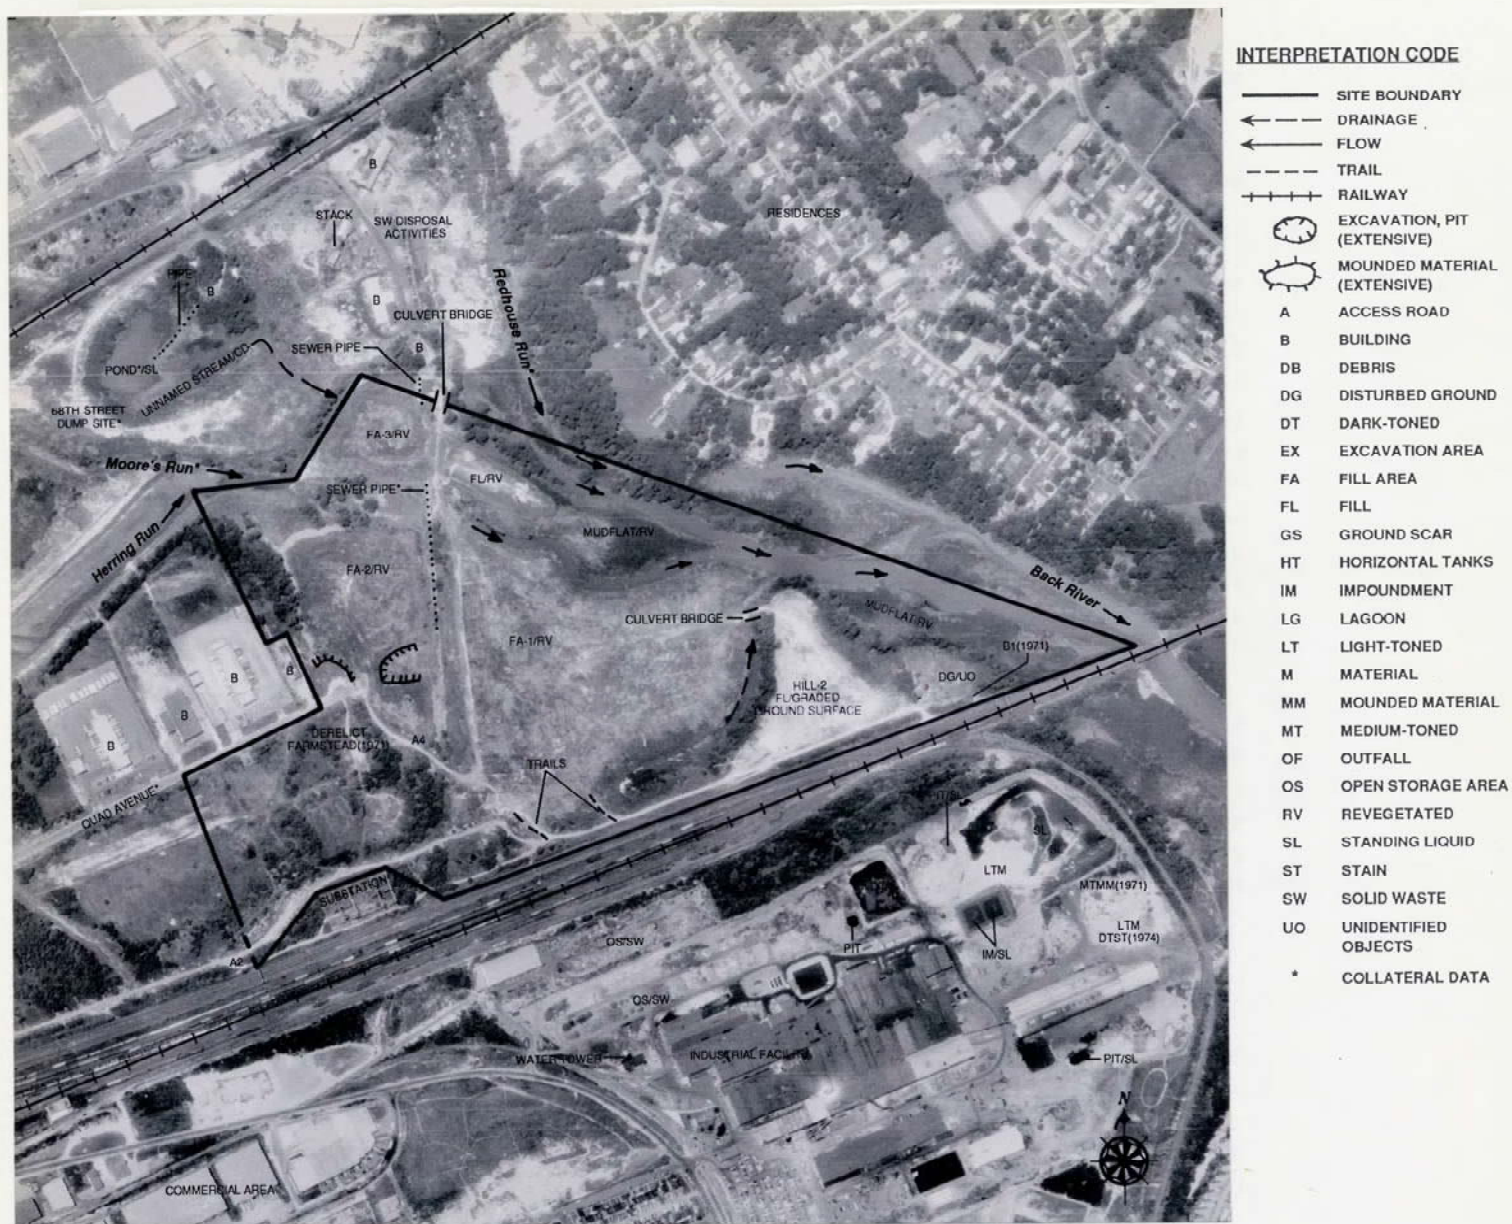
Figure 12. Industrial Enterprises site, June 14, 1973. Approximate scale 1:7,000.

JUNE 14, 1973 (FIGURE 12)

At Hill-2, building B1 has been removed. At the eastern end of Quad Avenue, delineation of the northern face of the embankment is noted. The remainder of the site appears relatively unchanged since 1971.

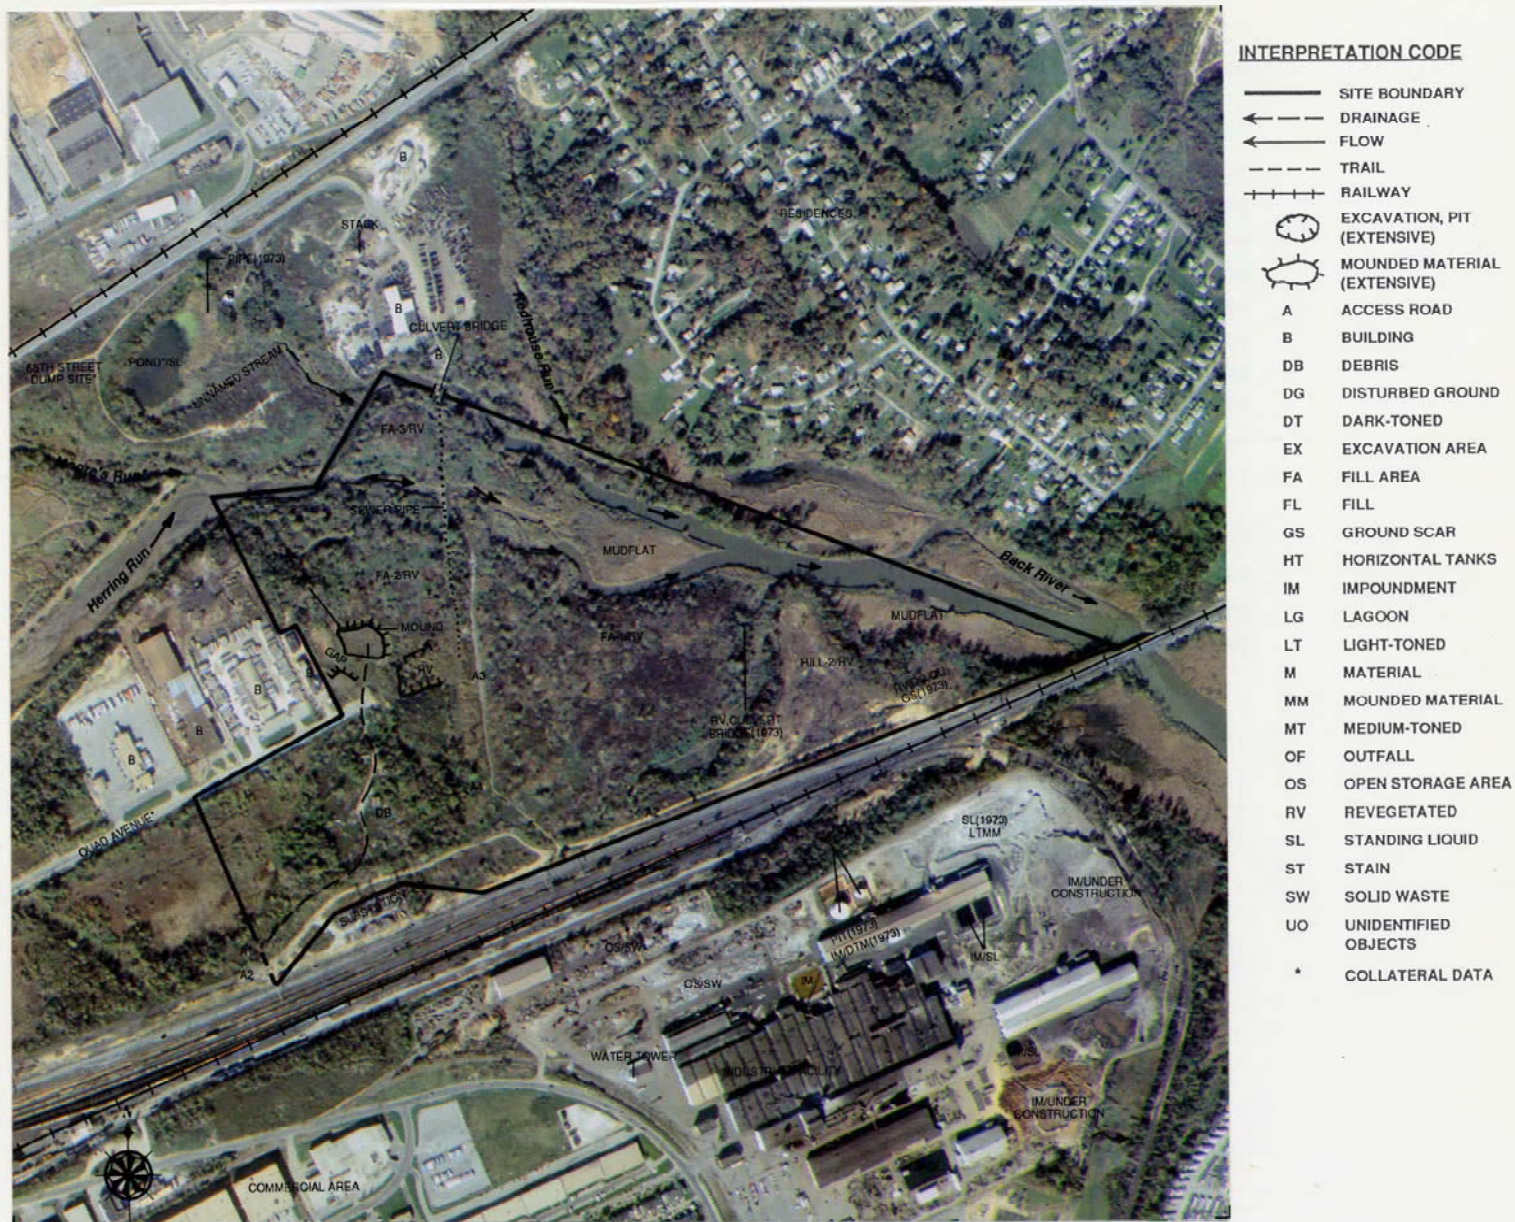
Figure 13. Industrial Enterprises site, November 3, 1984. Approximate scale 1:7,110.

NOVEMBER 3, 1984 (FIGURE 13)

Stereoscopic coverage of this date analysis was not available, so the analysis was done monoscopically on the single photo transparency.

Revegetation partially obscures the length of the sewer pipe and the excavation area located along the southern side of FA-2. Beyond the northeastern end of Quad Avenue, a ditch has been established since 1984. This ditch separates a discrete, flat-topped portion of fill material, now identified as a mound, from the rest of fill area FA-2. A gap now present between the flat-topped mound and the northeastern side of Quad Avenue is noted. From the southwest corner of the site, a segment of access road A1 extends northward to this flat-topped area. Debris is visible along the eastern side of this segment of access road A1. At Hill-2, the ground surface is revegetating. An area with ground scarring remains visible near the southeastern corner of Hill-2, where revegetation obscures the disturbed ground and unidentified objects visible in 1973.

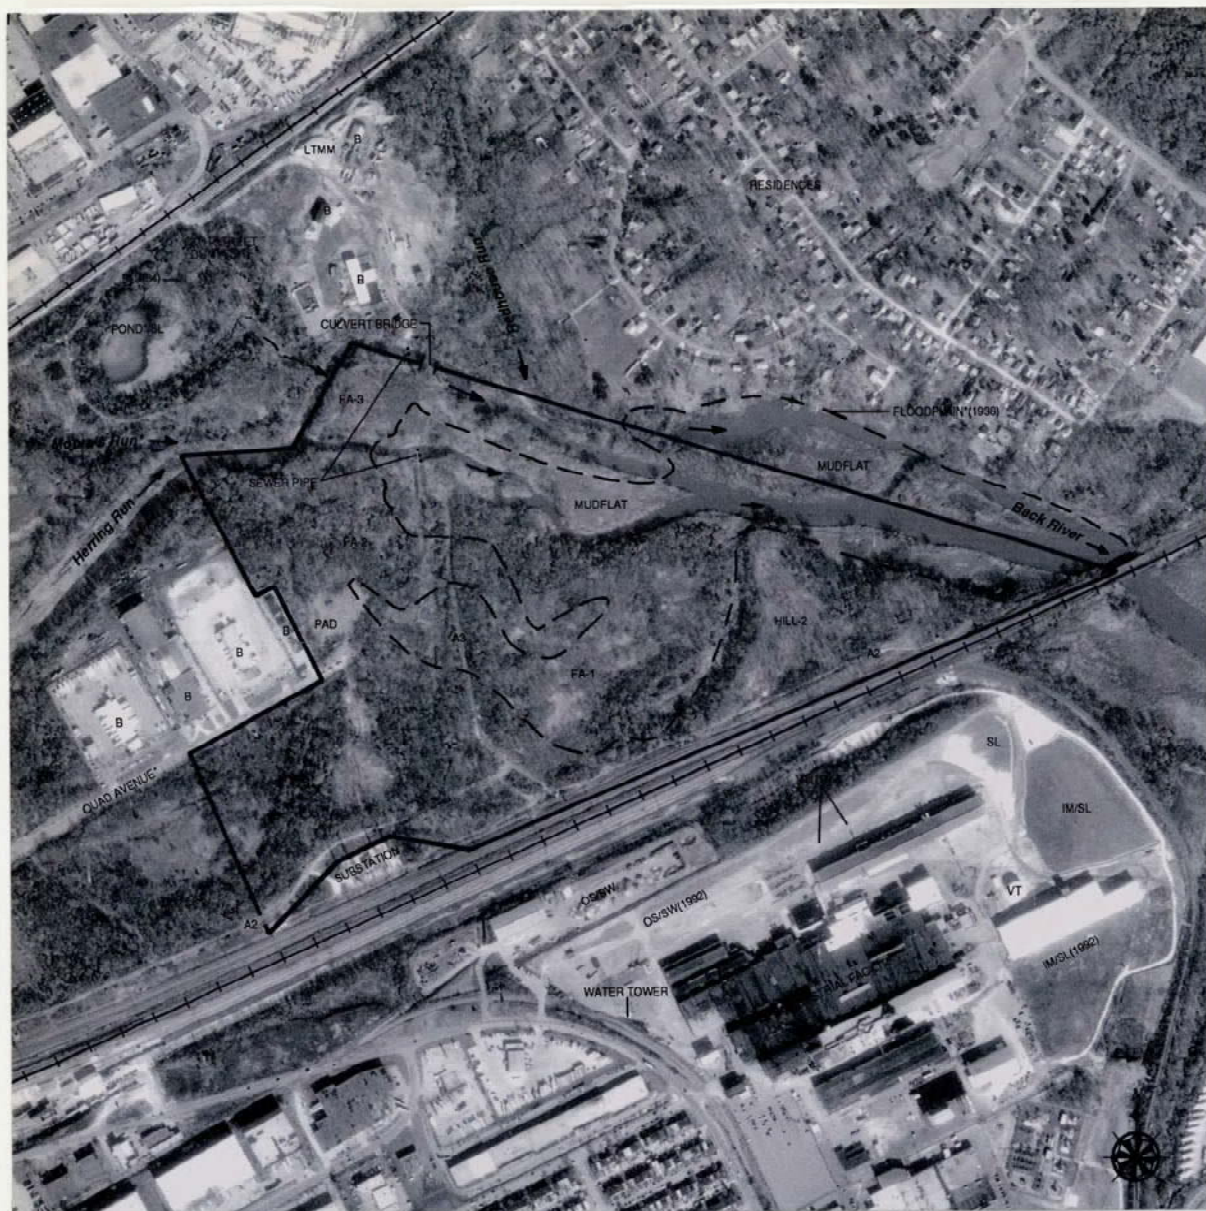
Figure 15. Industrial Enterprises site, February 9, 1998. Approximate scale 1:7,110.

FEBRUARY 9, 1998 (FIGURE 15)

The approximate location of the floodplain initially identified and delineated on the 1938 photograph (Figure 3) is represented by dashed lines on this photograph. The site appears inactive, with no environmentally significant developments since 1992.
